FHWA/IN/JTRP-2001/10-II

**FATIGUE BEHAVIOR OF BEAM DIAPHRAGM CONNECTIONS
WITH INTERMITTENT FILLET WELDS**

**PART II: BRITTLE FRACTURE EXAMINATION OF THE I-64
BLUE RIVER BRIDGE**

Purdue University
West Lafayette, IN 47907-1284
March 2002

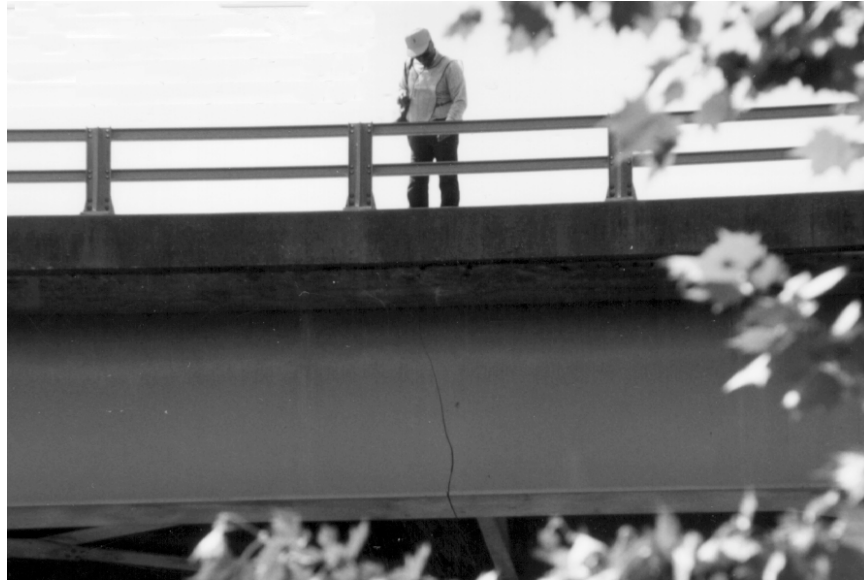
Sometime after a routine inspection during the Fall of 1993, the Interstate 64 highway bridge over the Blue River in southern Indiana suffered a severe brittle fracture in one of the outside girders. The fracture, shown in Figure 1.1, severed the bottom flange and all but 25 mm (1 in) of the 1778 mm (70 in.) deep web plate. The bridge was supported by the three remaining girders until an Indiana Department of Transportation maintenance crew discovered the fracture in May 1994. This report details subsequent research conducted at Purdue University to evaluate the causes of the fracture and to formulate recommendations concerning repairs for similarly designed bridges in Indiana.

Figure 1.1 View of brittle fracture in the outside girder of the I-64 Blue River Bridge

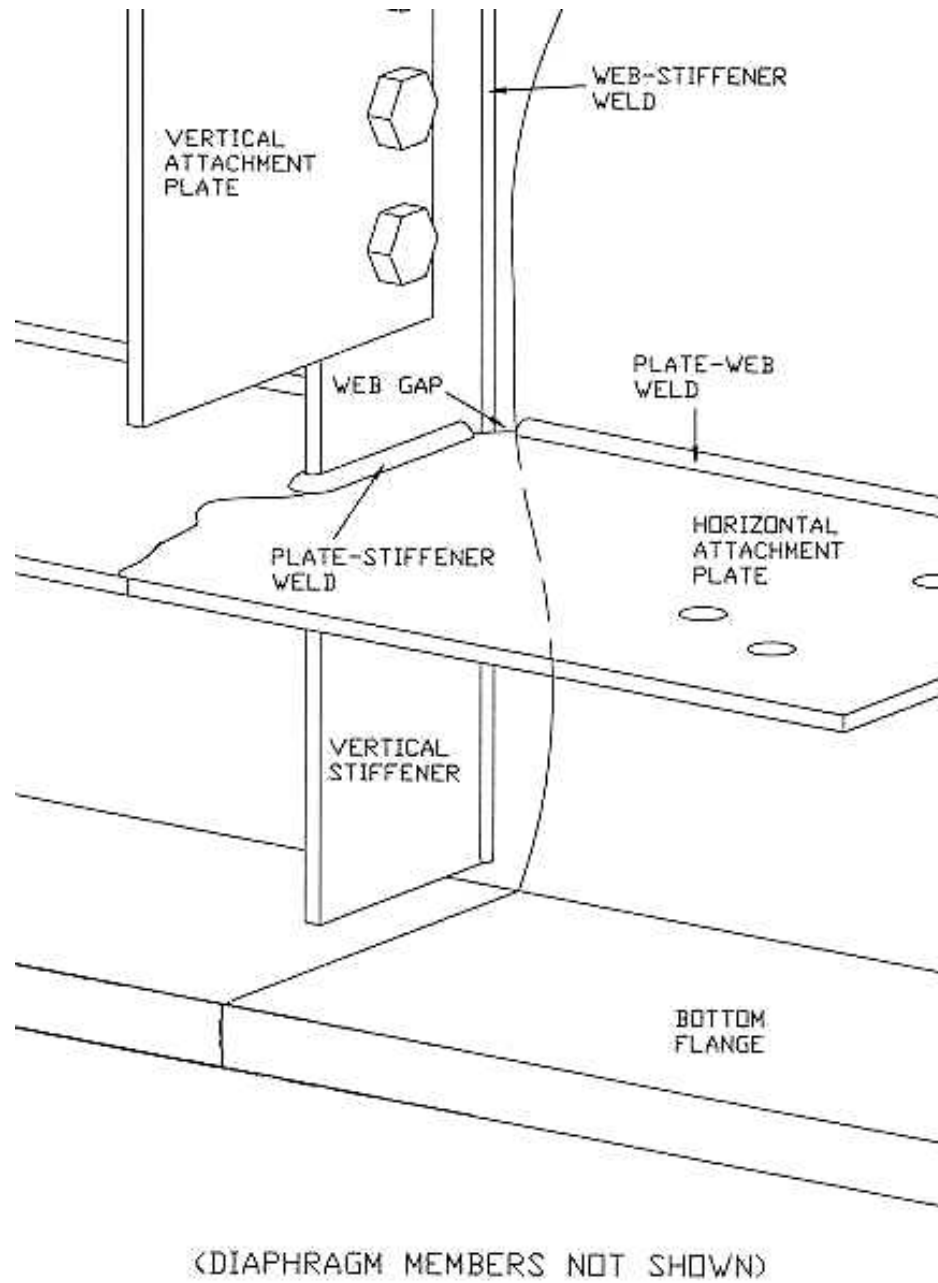
A location of particular interest is the portion of the girder where the vertical stiffener and the horizontal gusset plate intersect. Note how the crack passes through the region of the web, hereafter called the web gap, bounded by the vertical stiffener and a chamfered corner of the horizontal attachment plate (see Figure 1.5). The photographs in Figures 1.12 and 1.13 reveal that at this corner the crack just touches the protruding toe of the fillet weld that runs along the bottom of the horizontal attachment plate and connects the plate to the web. The brittle fracture clearly emanated from this web gap region.

Figure 1.5 Close-up view of crack position relative to the vertical stiffener and the horizontal attachment plate

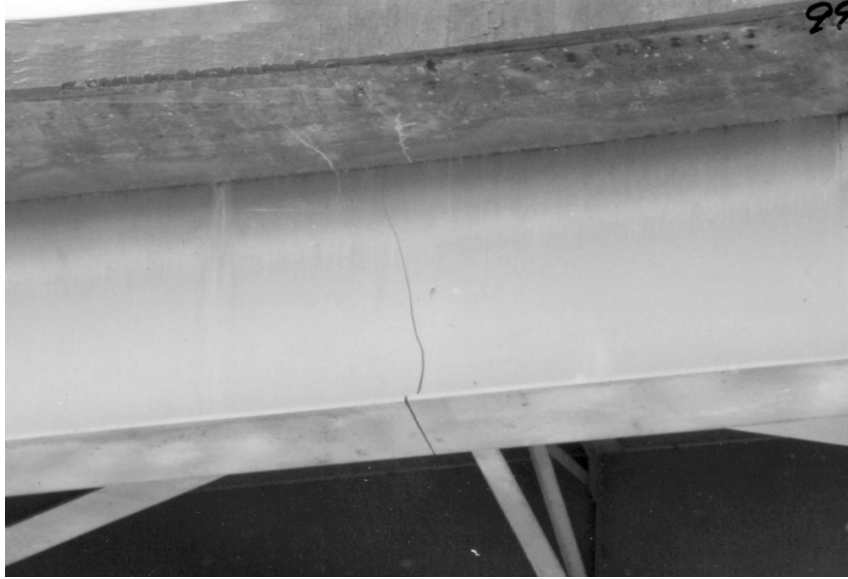
Figure 1.6 View of brittle fracture in the outside plate girder

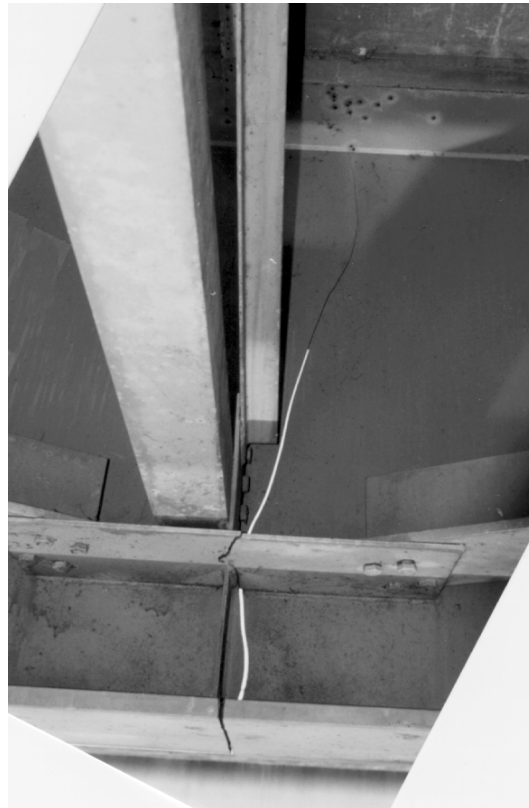
Figure 1.7 View of crack through the flange, web and gusset plate

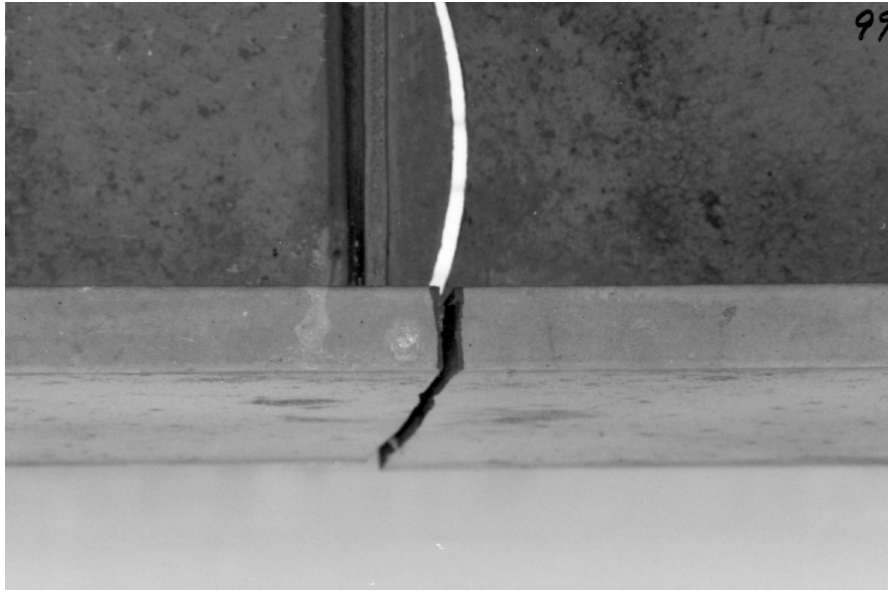
Figure 1.8 View of fracture through the bottom flange of the girder

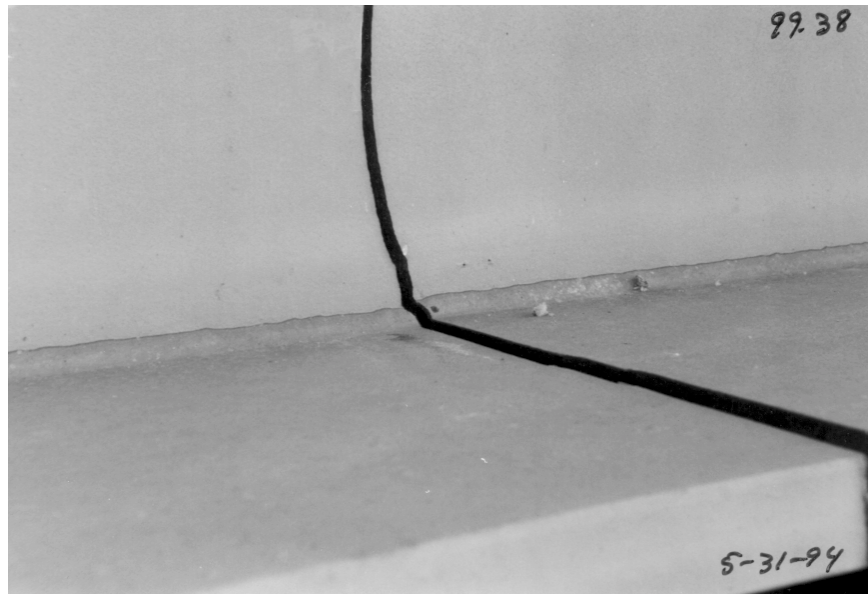
Figure 1.9 View of fracture from the top surface of the bottom flange

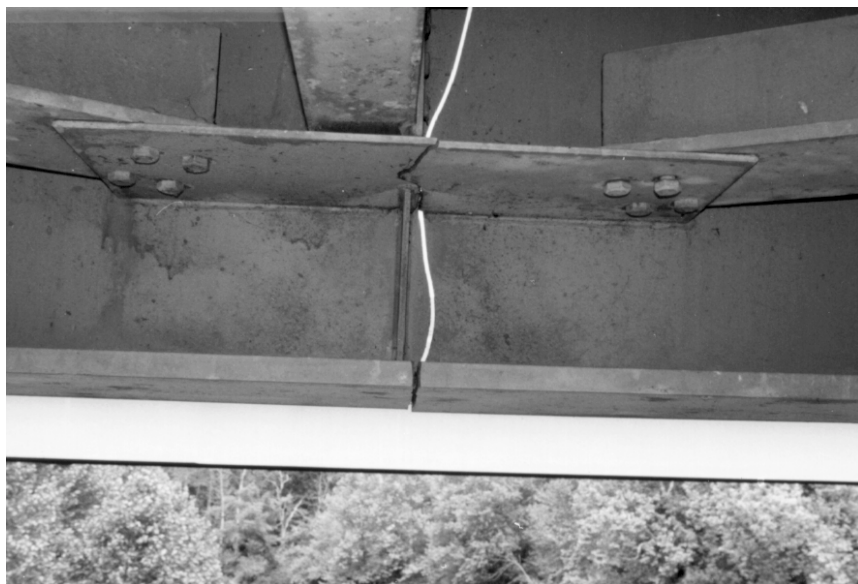
Figure 1.11 View of fracture at bottom connection detail

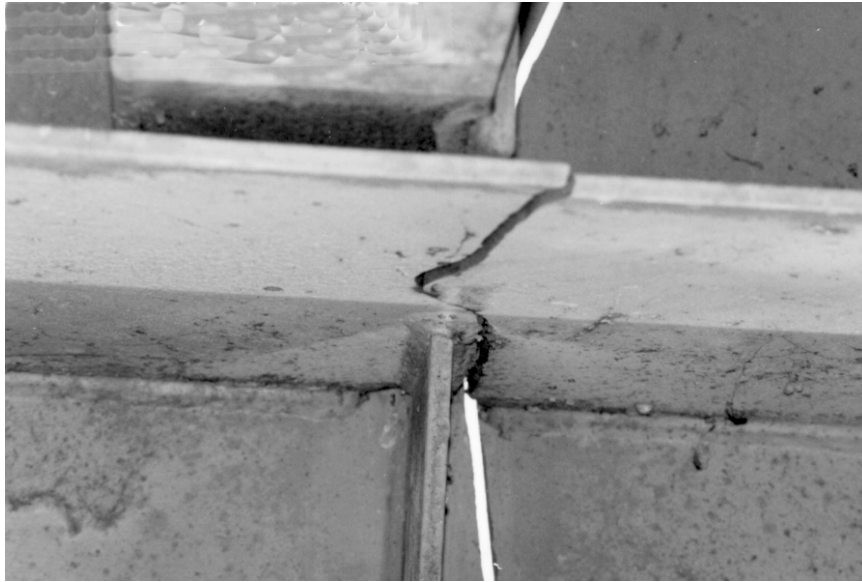
Figure 1.12 Close-up view of fracture through the attachment plate

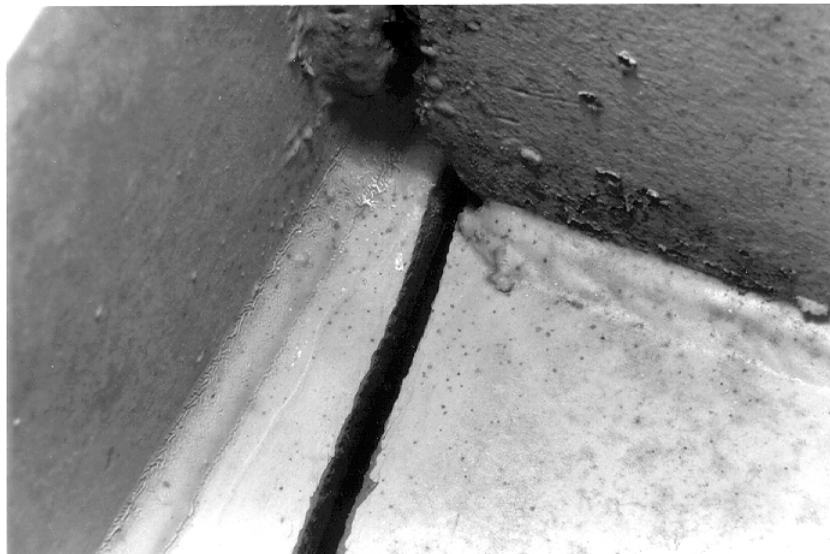
Figure 1.13 View of crack at the weld toe at the chamfered edge of the horizontal gusset plate

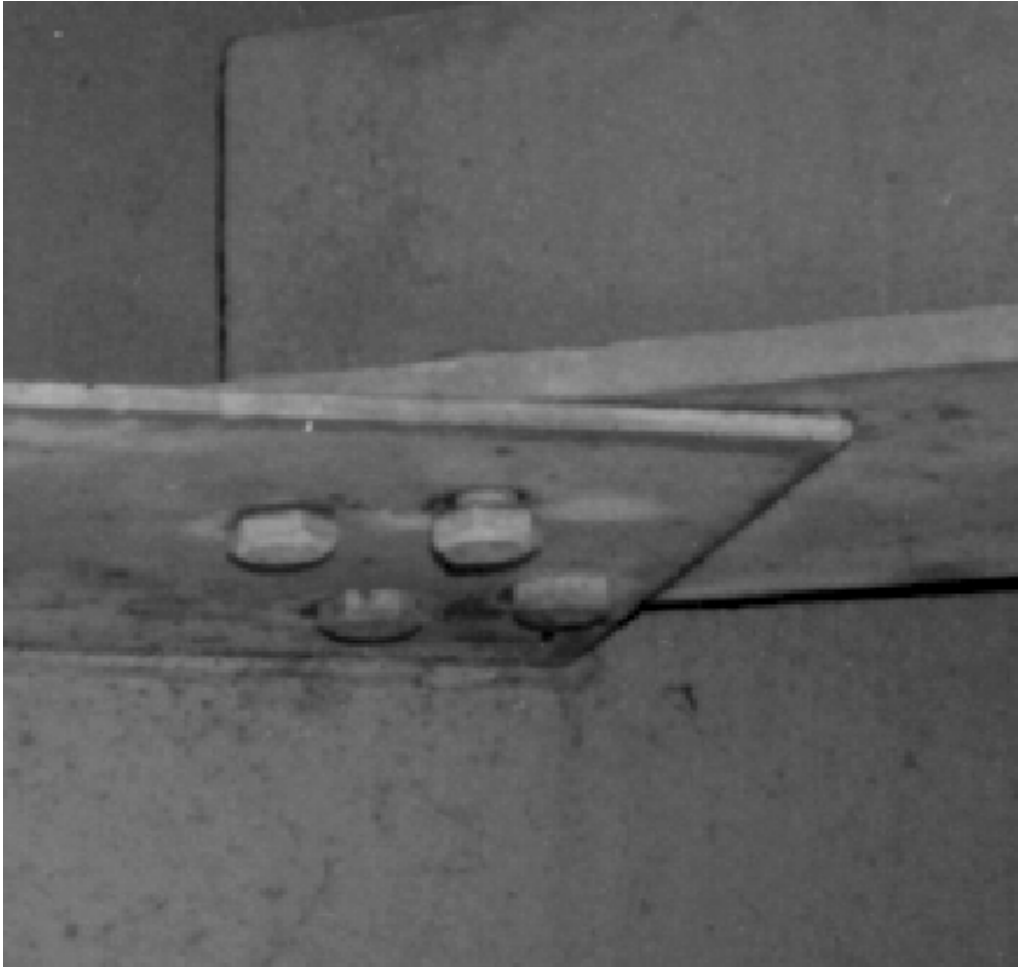
Figure 3.2 View of loose bolt at lateral brace to gusset plate connection

Tighten or replace all loose bolts that are used to connect the horizontal bracing members to the lateral gusset plate. Also, all conditions that may introduce excessive impact should be corrected to minimize damaging longitudinal forces.

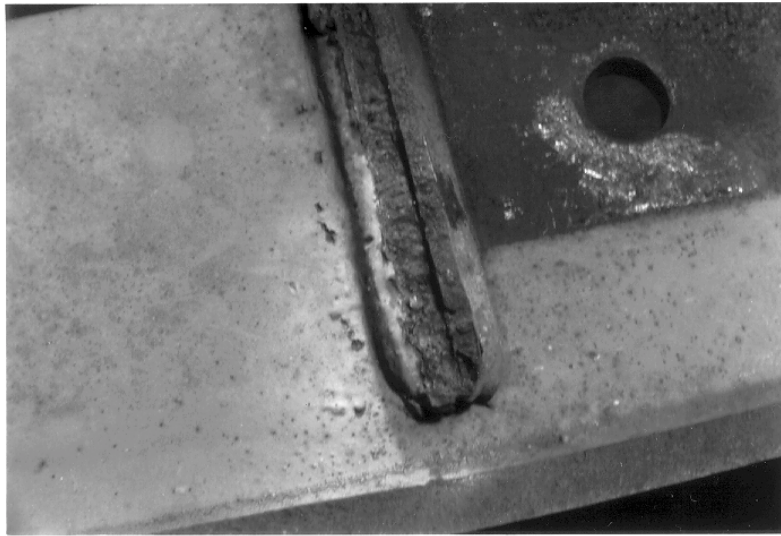
No evidence of fatigue striations was found in the region suspected to be the origin of the fracture. Although this may indicate that very little fatigue crack growth occurred, it is believed, instead, that the iron oxide layer on the fracture surface masked the striations. In any event, the microscopic examination of the fracture surface proved to be inconclusive.

Figure 3.10 Close-up view of Part E crack surface

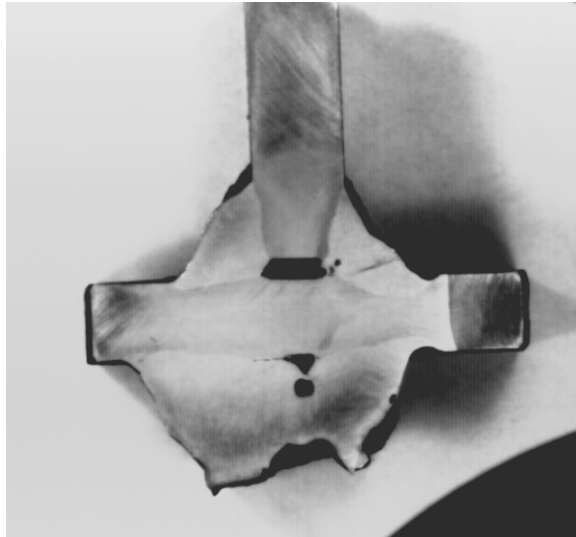
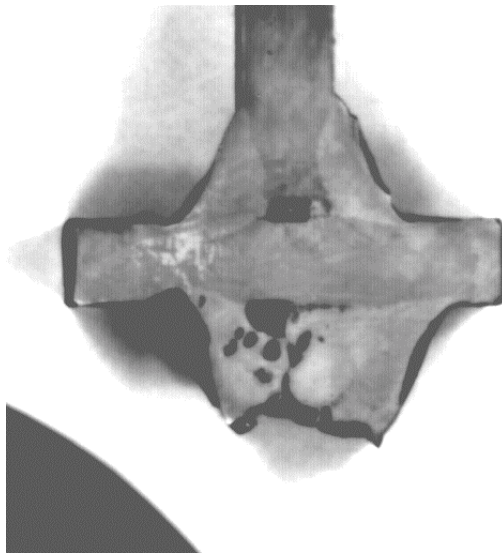
Figure 3.13 View of stiffener to horizontal gusset plate weld

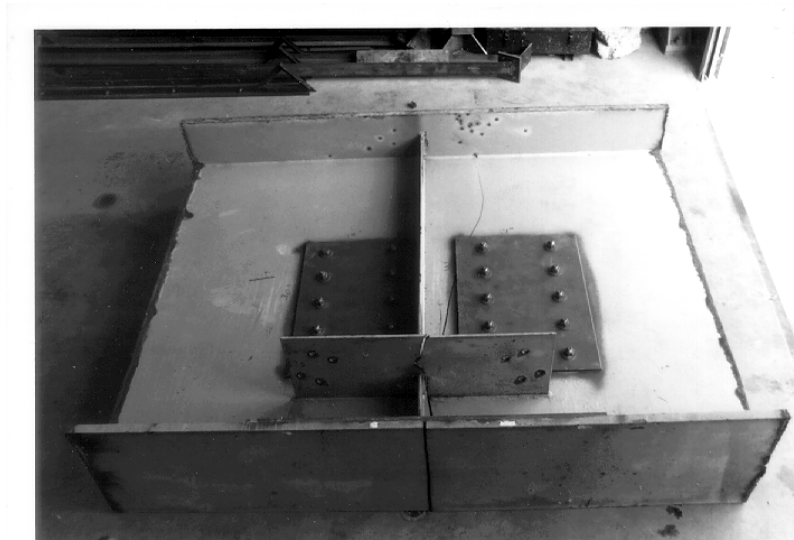
Figure 4.1 View of cracked bridge girder upon arrival at Purdue University
